Inspect, so you know what to Expect.sm

Site Location:
Anywhere, OK

Client:
Sample Customer
Anywhere, OK

Inspection Date: 0/00/2006
Inspection Time: 3:00:00 PM
Job Number: XXXX

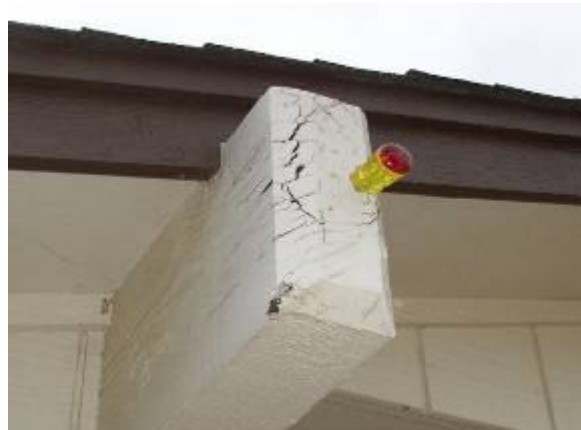
Trim: Vinyl, Wood
Conditions: **Dry rot ---** Dry rot is decomposition in seasoned wood caused by fungi. Recommend repair of affected area as needed.

Rating: Defective

Condition: Dry rot - Dry rot is decomposition in seasoned wood caused by fungi. Recommend repair of affected area as needed.

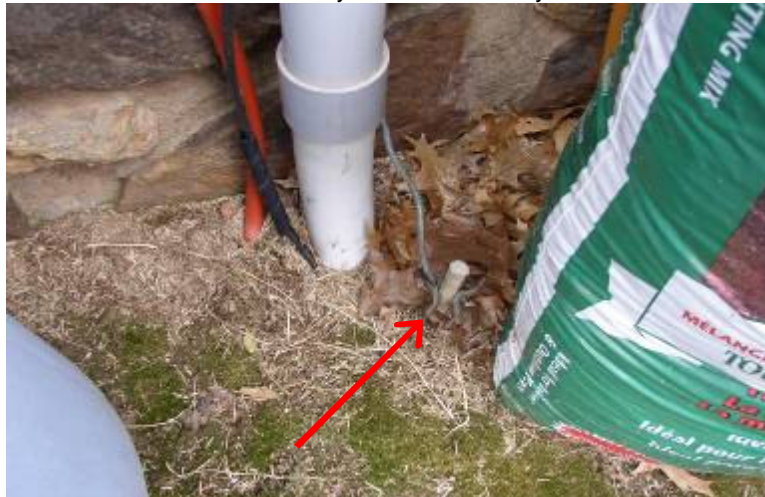
Ground: Buried Electrode
Conditions: **Loose ground** --- The ground connection is loose and may not operate properly. This should be corrected to insure the safety of the electrical system.

Rating: Defective

Condition: Loose ground - The ground connection is loose and may not operate properly. This should be corrected to insure the safety of the electrical system.

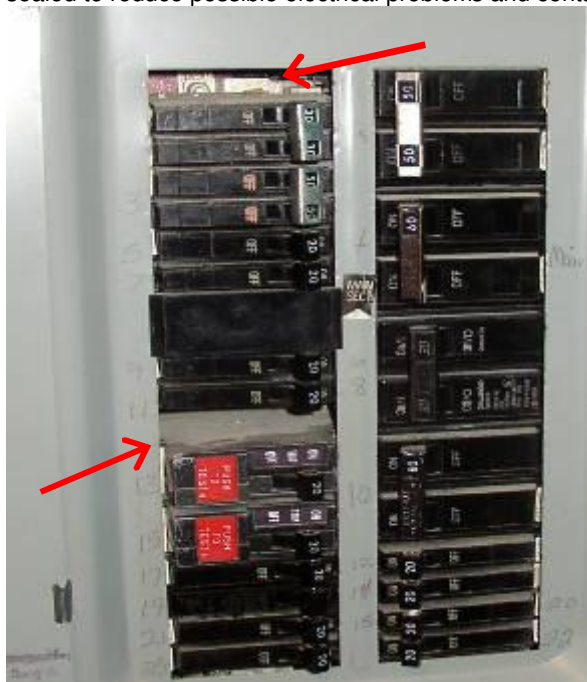
Open knockout --- Knockouts are open in the service panel. All knockouts should be properly sealed to reduce possible electrical problems and contain fire within cabinet.

Condition: Open knockout - Knockouts are open in the service panel. All knockouts should be properly sealed to reduce possible electrical problems and contain fire within cabinet.

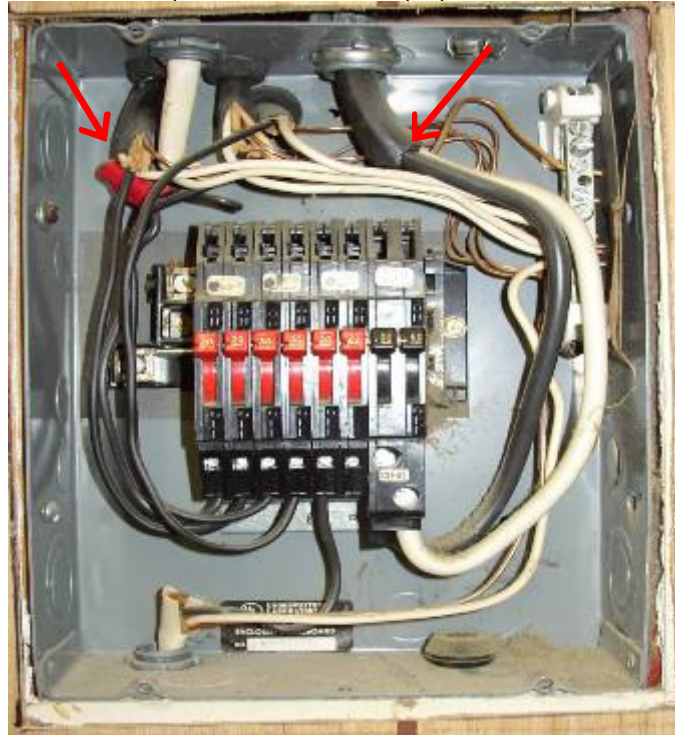
No 4 wire feed --- The neutral conductor of the feeder cable in the sub panel is not fully insulated as required. Recommend a proper feeder cable be installed.

Improper splice --- Improper splicing was noted. Electrical continuity could be questionable, repair if needed.

Defective

Condition: No 4 wire feed - The neutral conductor of the feeder cable in the sub panel is not fully insulated as required. Recommend a proper feeder cable be installed.

Condition: Improper splice - Improper splicing was noted. Electrical continuity could be questionable, repair if needed.

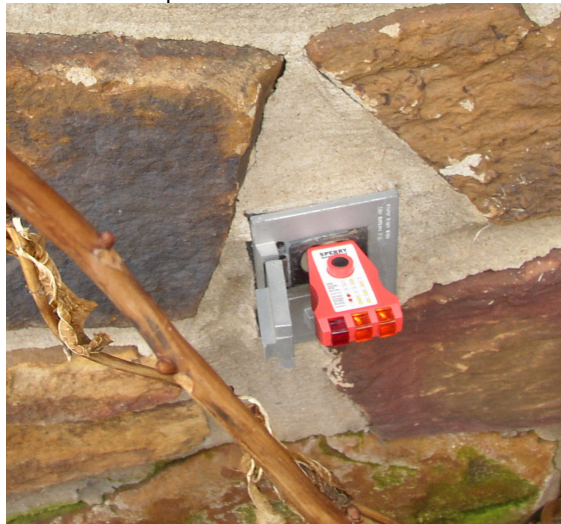
Conditions: **GFCI ok ---** Using a ground fault interrupter (G.F.I.) tester, receptacles checked, indicated a properly functioning G.F.I.
GFCI needed --- The inspector suggests a GFCI for this location to reduce the risk of shock. These Ground Fault Current Interrupters are relatively inexpensive.
Location: Receptacle below window AC unit.

Rating: **Defective**

Condition: GFCI needed - The inspector suggests a GFCI for this location to reduce the risk of shock. These Ground Fault Current Interrupters are relatively inexpensive.

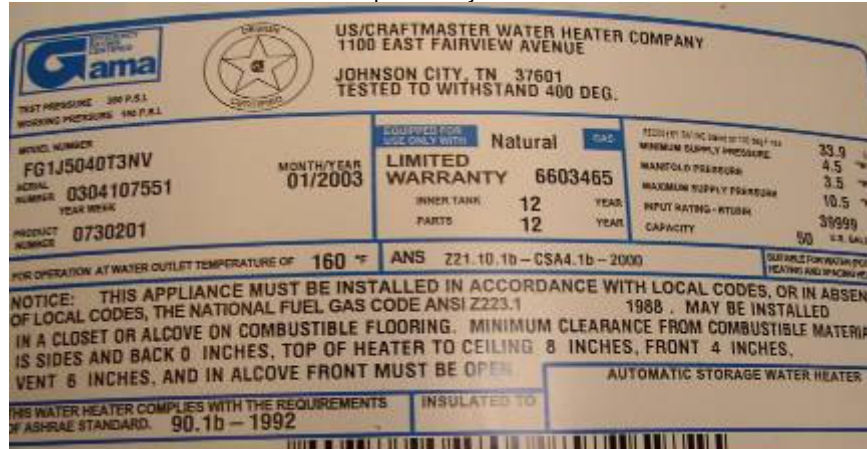
Age: 2 to 5 yrs
Conditions: **Data Plate** --- Photo of units' data plate for your reference.

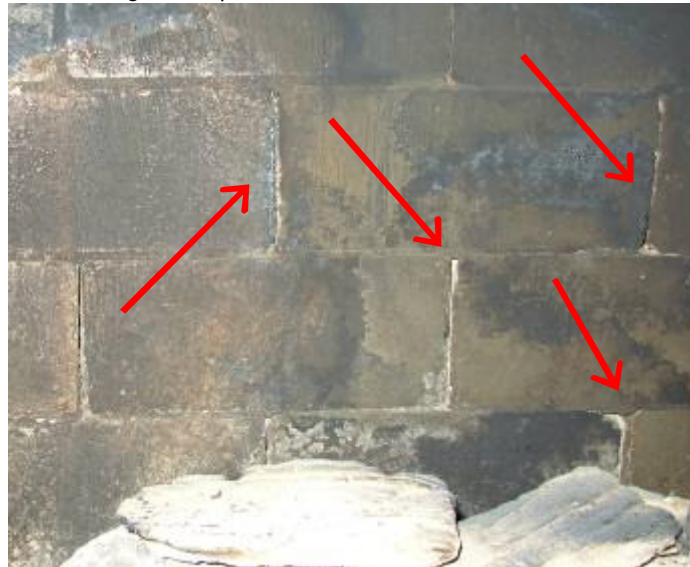
Fireplace: Wood Burning
Conditions: **Firebox mortar damage ---** Mortar damage was observed in the fireplace lining. Repair before using the fireplace.

Rating: **Defective**

Condition: Firebox mortar damage - Mortar damage was observed in the fireplace lining. Repair before using the fireplace.

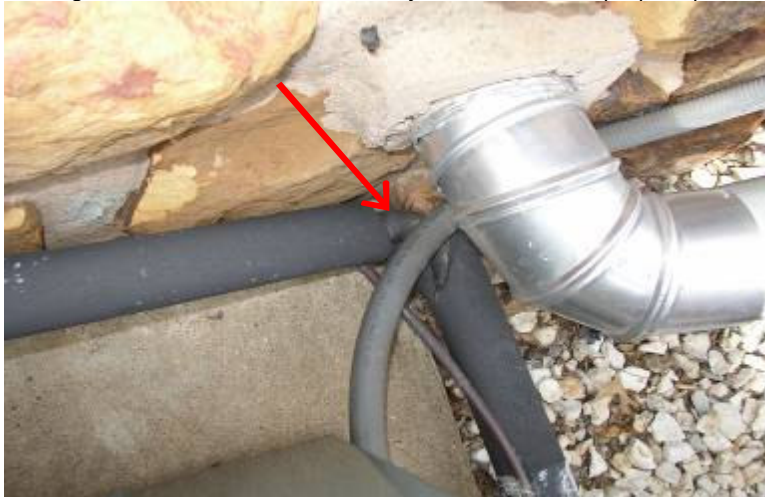
Conditions: **AC ok** --- Turned down thermostat, system started and was functional.
Lines need insulation --- Section of the insulation on the compressor lines appear to be missing. These lines should be suitably insulated for the proper operation of the compressor.

Rating: **Marginal**

Condition: Lines need insulation - Sections of the insulation on the compressor lines appear to be missing. These lines should be suitably insulated for the proper operation of the compressor.

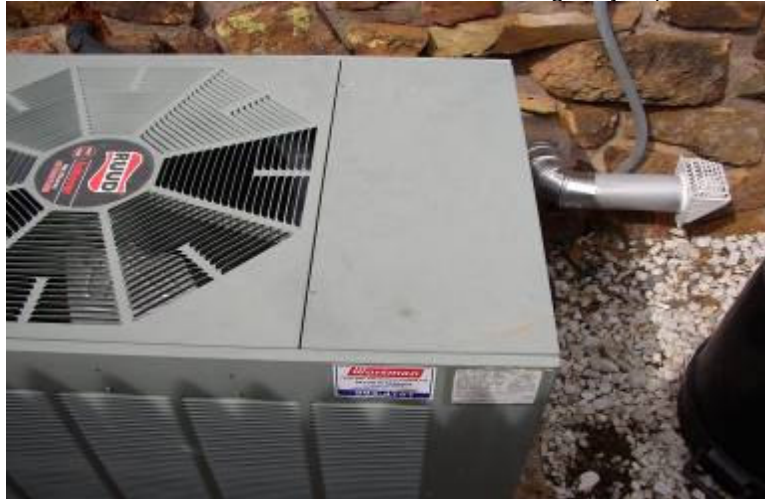
Conditions: **Dryer vents near AC** --- Clothes dryer vent is in close proximity to A/C condenser unit. Excess lint from dryer could build up on coils, causing inefficiency and premature wear. A/C condenser unit should be monitored and cleaned regularly to prevent lint build up.

Rating: Maintenance Required

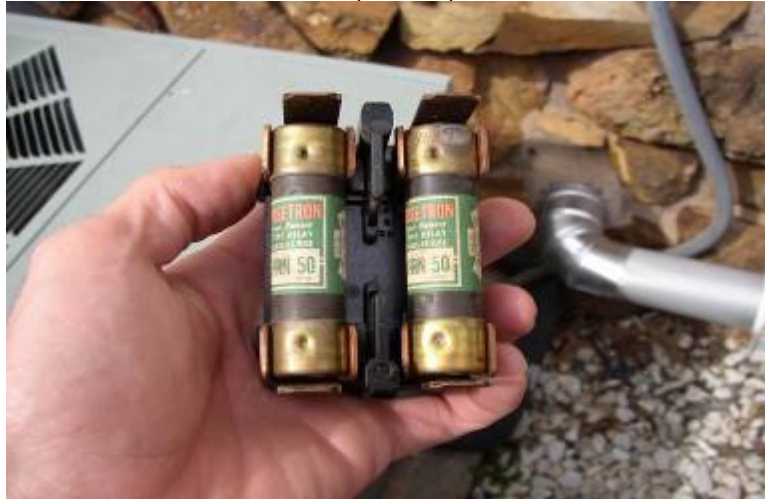
Conditions: **Over fusing** --- The panel has over fusing. This means that one or more circuits have a fuse or circuit breaker that is too large for the wire connected to it. This is a potentially dangerous situation. Have an electrician inspect the panel and correct.

Comments: Unit calls for 45 amp max fusing. Fuses installed at disconnect are 50 amp.
Rating: **Defective**

Condition: Over fusing - The panel has over fusing. This means that one or more circuits have a fuse or circuit breaker that is too large for the wire connected to it. This is a potentially dangerous situation.

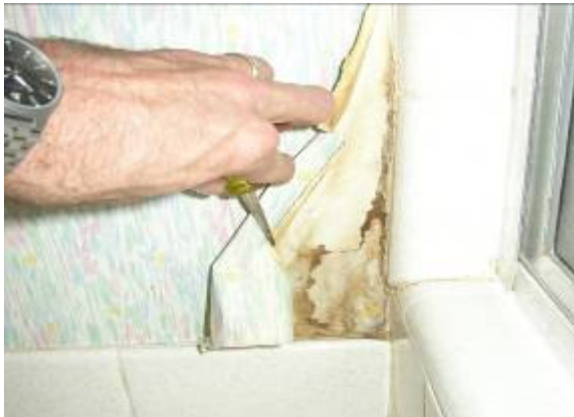
Type: Drywall
Conditions: **Cracks (minor)** --- Some cracks were noted that are minor in nature. Small settlement cracks are a common occurrence and can be repaired, providing that the settlement has stopped.
Peeling paper --- Peeling wallpaper was noted, which could be a sign of excessive moisture. Repair as needed.
Location: master bath

Physical damage --- Physical damage was noted and should be repaired.
Location: master bath
Rating: Marginal

Condition: Physical damage - Physical damage was noted and should be repaired.

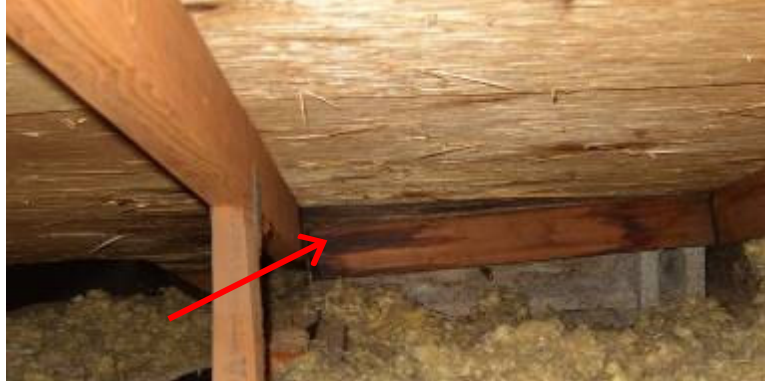
Roof Framing: Truss
Conditions: **Framing pulled** --- Framing is pulled away from its expected position.

Rating: Defective

Condition: Framing pulled - Framing is pulled away from its expected position.
